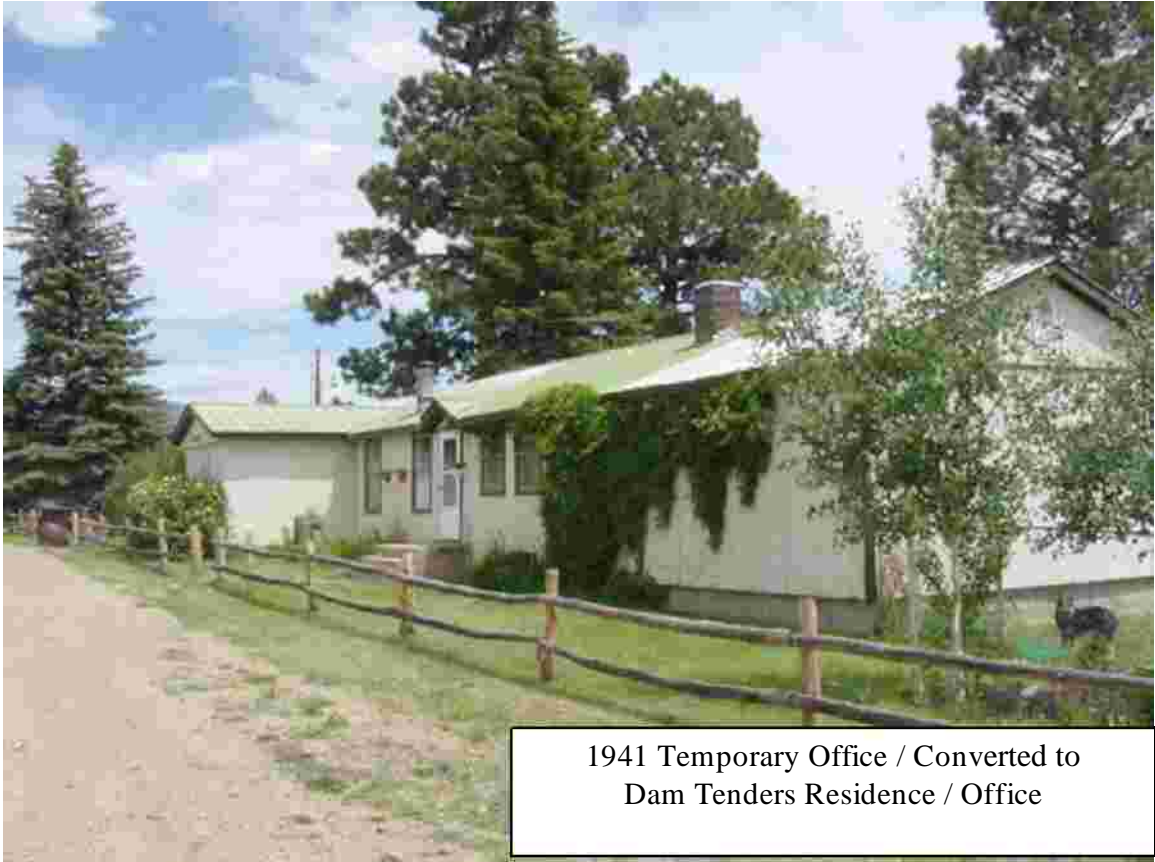
1941 Temporary Office / Converted to
Dam Tenders Residence / Office

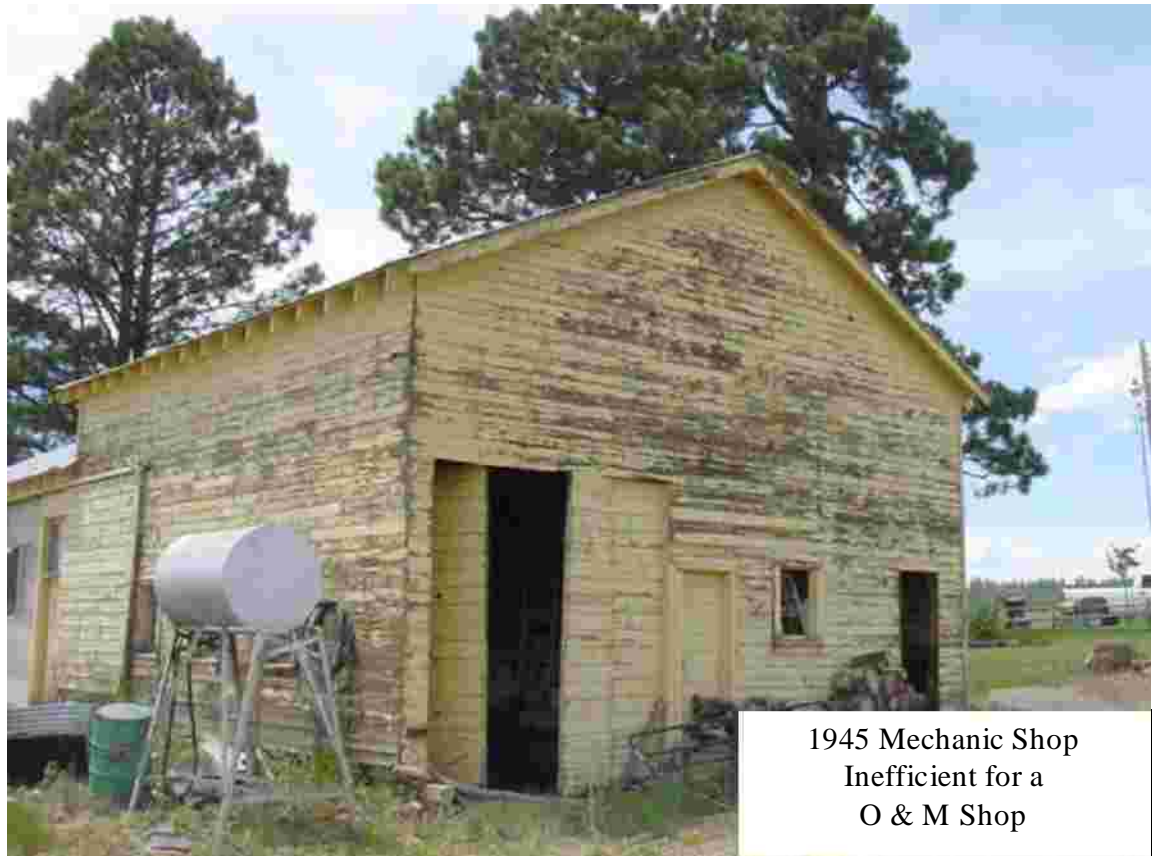
1945 Mechanic Shop
Inefficient for a
O & M Shop

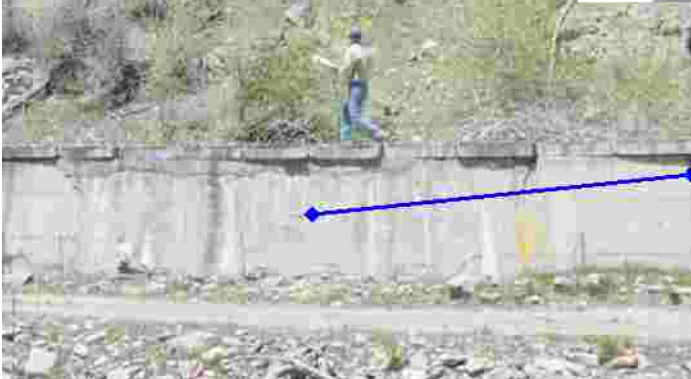
Patch in Canal Wall Due to Rock Fall

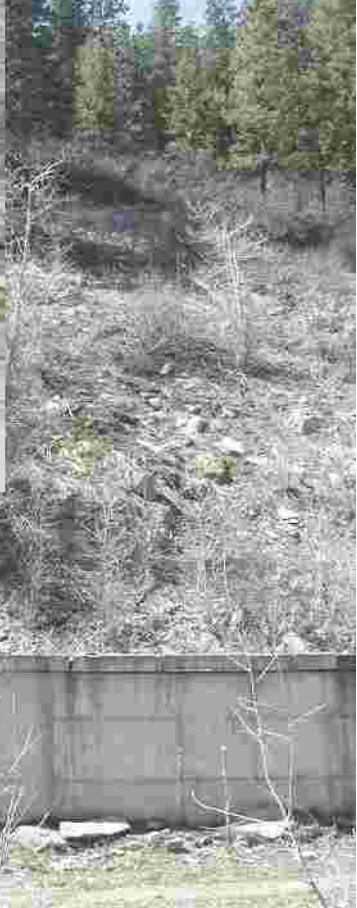
Annually Rocks This
Size Roll Down the
Slope
200 - 400 lbs

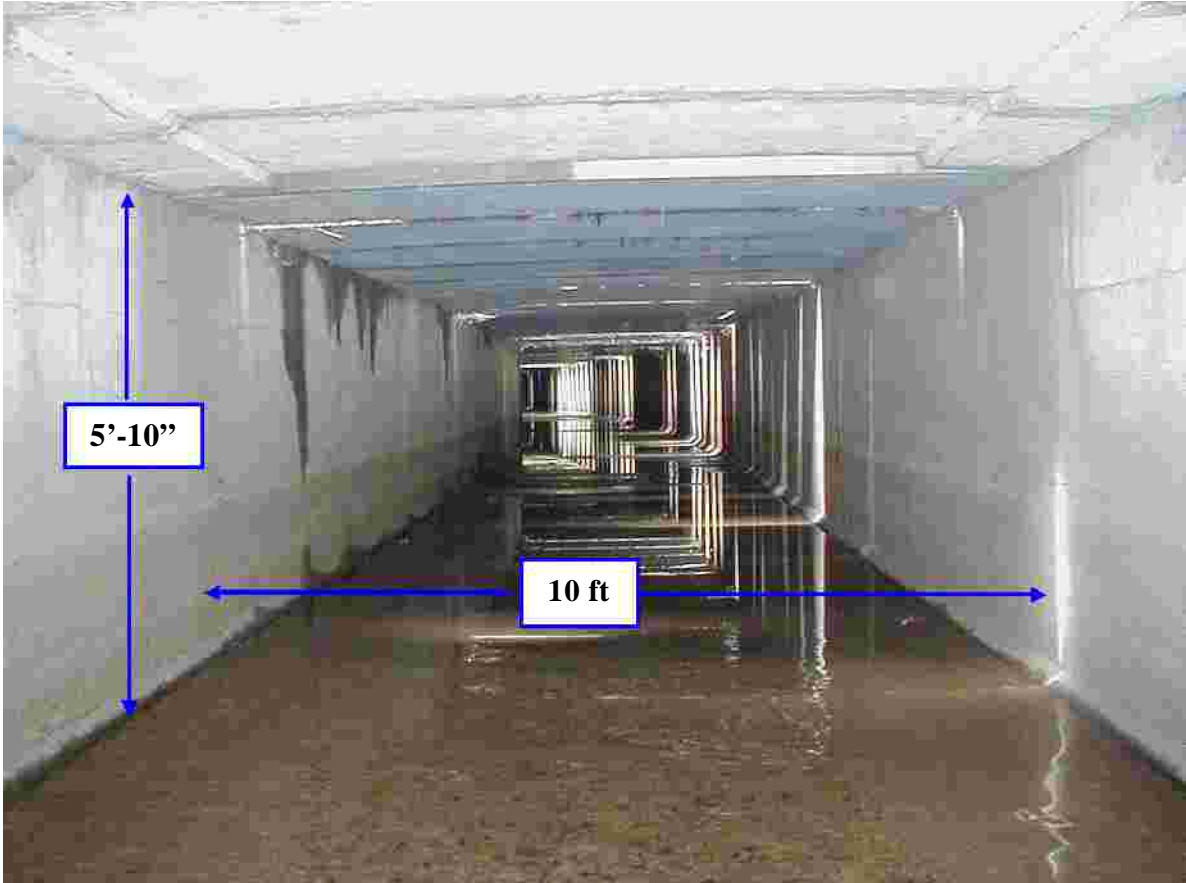
Need for Lining

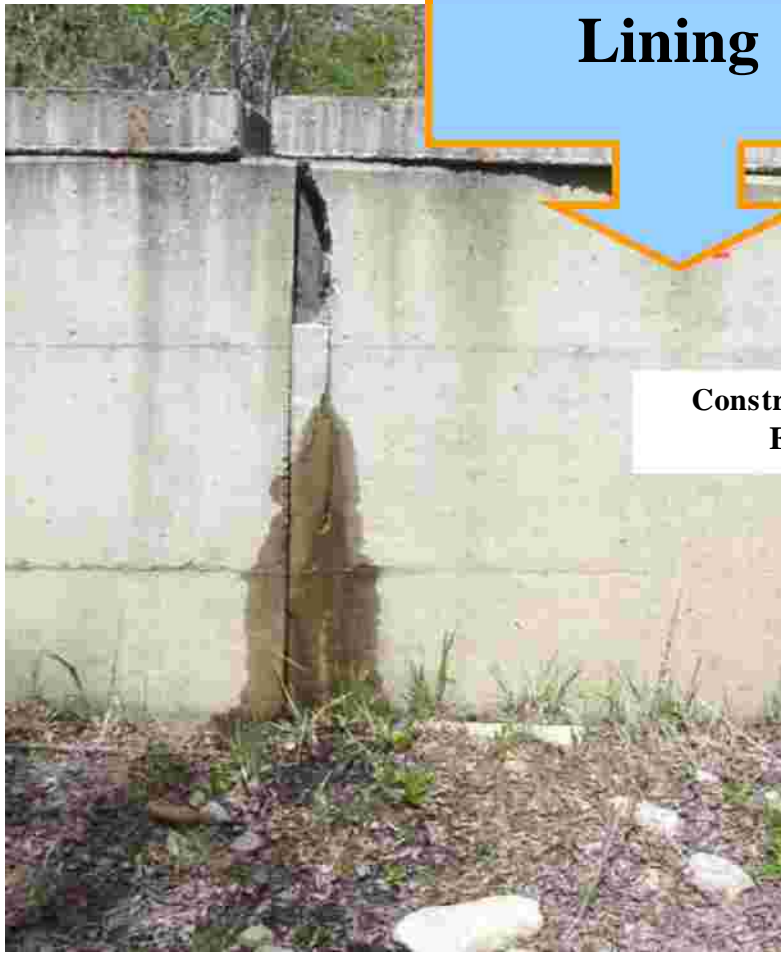
Construction Joint Failure

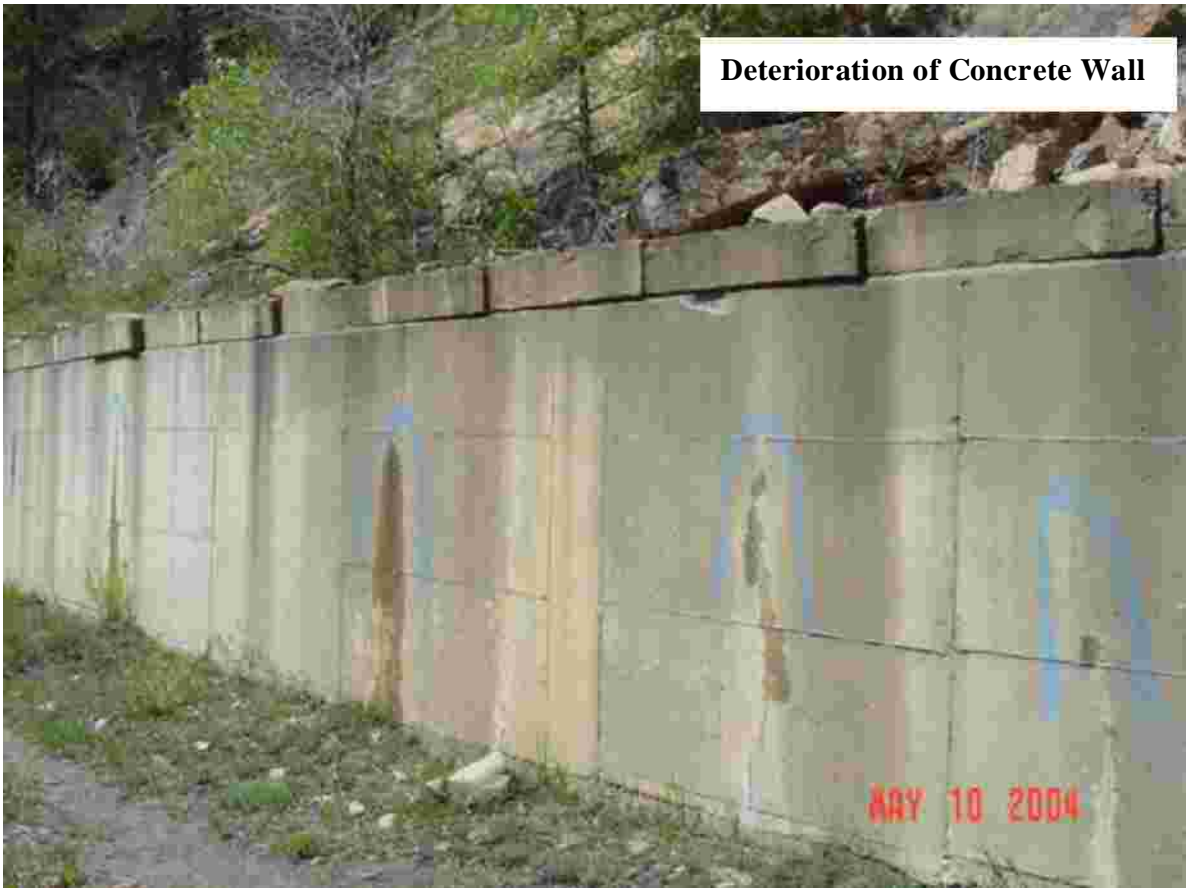
Deterioration of Concrete Wall
