Mancos Water Conservancy District

JACKSON GULCH RESERVOIR

Recognizing the burden of their responsibility, the Mancos Water Conservancy District entered into a contract with Buckhorn Geotech, Inc. on September 18, 2003, to conduct a thorough assessment and evaluation of the condition of the canal system and identify restoration and rehabilitation work necessary to extend the life of the canal system, improve access and operational efficiency, protect against catastrophic losses, and assure dependable water delivery.

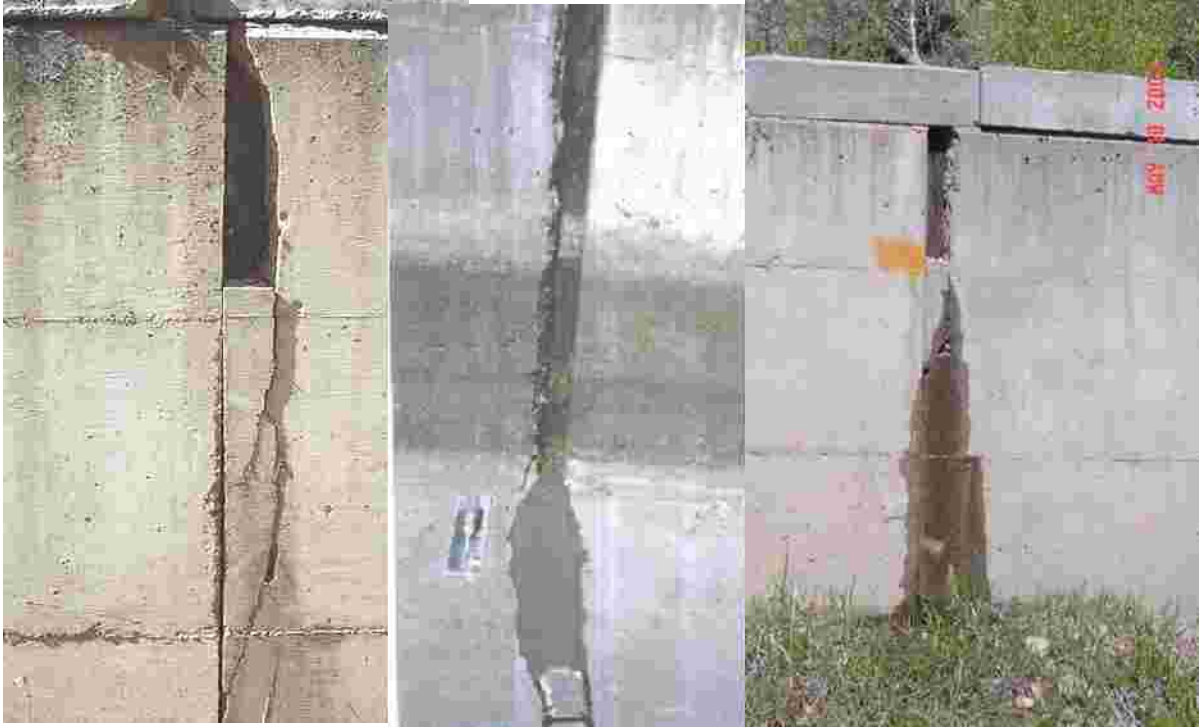
- 53% of the joints in the northern concrete bench flume section have experienced serious deterioration as have 46% of the joints in the southern concrete bench flume section. This deterioration is causing reduced structural integrity and seepage losses.

- Rehabilitate concrete blowouts, scoured floors, and damaged joints within the concrete bench flumes, apply a waterproof synthetic liner over sides and floor of the flume, and apply a protective coating of gunnite concrete.

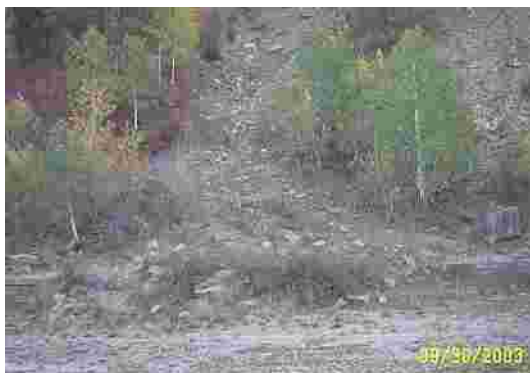
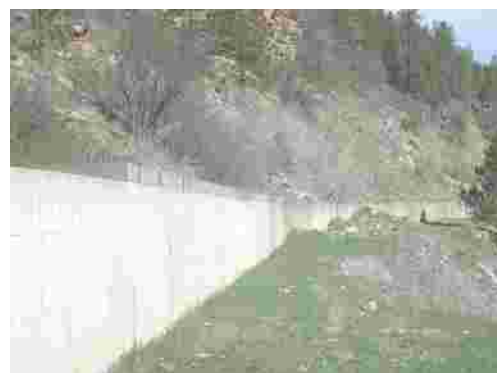
- 106 instances of concrete blowouts have been recorded in the concrete bench flume sections. These blowouts are gaps in and around the joints indicative of stress induced failure and deterioration of the concrete.
- Excessive lateral pressures from uphill slope failures, rockfall, soil creep, and debris flows have pushed sections of the concrete bench flume laterally, caused walls to be displaced, and created numerous stress cracks in the walls. Pressures in 320 linear feet of the concrete bench flume are approaching the ultimate load capacity of the walls and some wall sections are in danger of collapsing inward.

- Install drilled tie-back anchors into the hillside where additional protection from earth pressures and landslides is needed to preserve stability and prevent collapse of the flume walls.

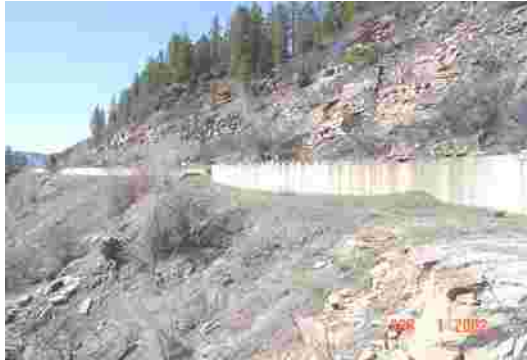
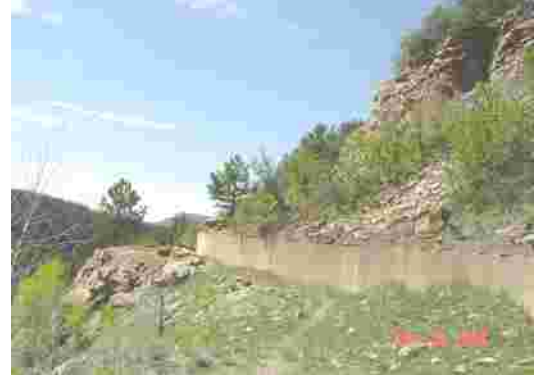
- Hundreds of cubic yards of rockfall and colluvial debris have accumulated atop the concrete bench flume. This debris may be in excess of the safe load capacity of the lids. Additional loading or rockfall impacts could cause the lids to collapse.

- Remove excessive overburden to prevent lid collapse while placing a wedge of soil over unprotected lid sections to provide mitigation against potential rockfall impacts.

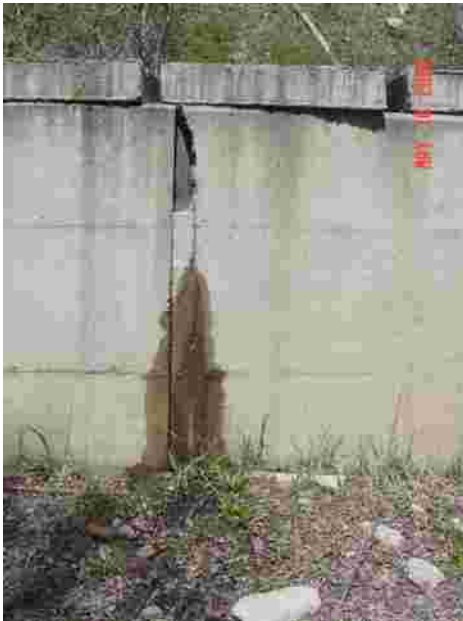
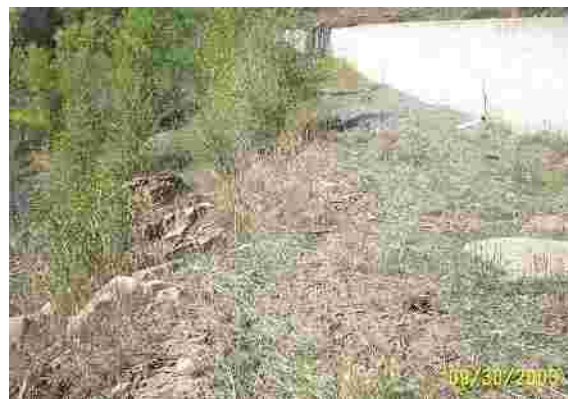
- 7000 square feet of the flume floor have experienced scour and damage from freezing of ponded water during winter periods.
- Seepage from leaking flume joints has contributed to slope instability problems resulting in loss of support in some areas along the base of the flume.

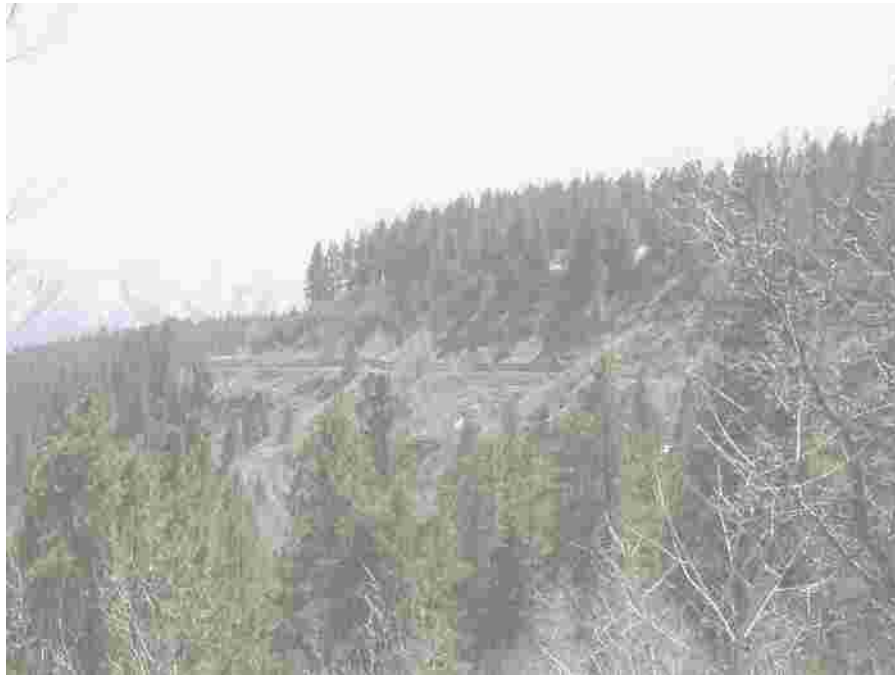
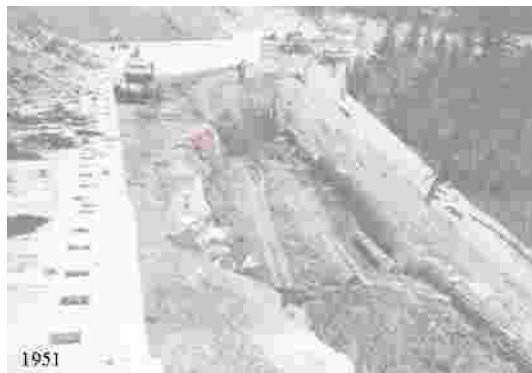
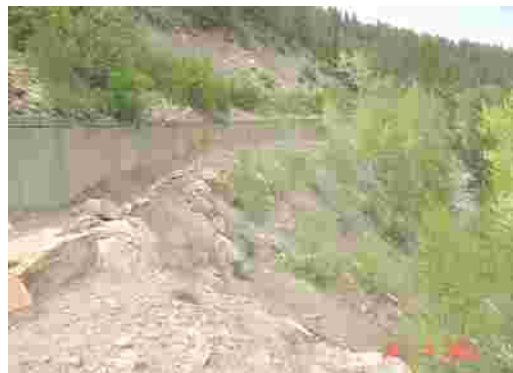
- Landslides have removed a large section of the access road alongside the flume so that approximately 2000 linear feet of canal cannot be accessed for maintenance purposes. Any failure of the flume within this section would result in a prolonged shutdown of the canal with severe consequences to Mesa Verde National Park, the Town of Mancos, Mancos Rural Water Company and the many farms and families that depend on this water source.

- Restore access along a 2000-foot length of canal by anchoring a retaining wall into the narrow canyon wall for restoration of a lost roadway section.

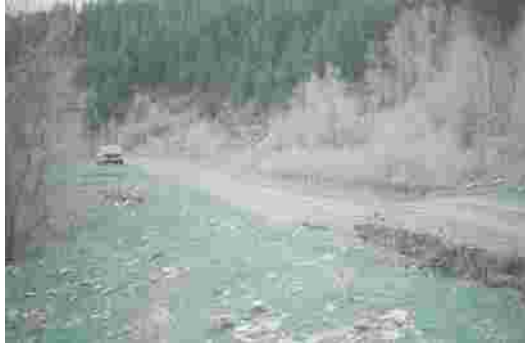
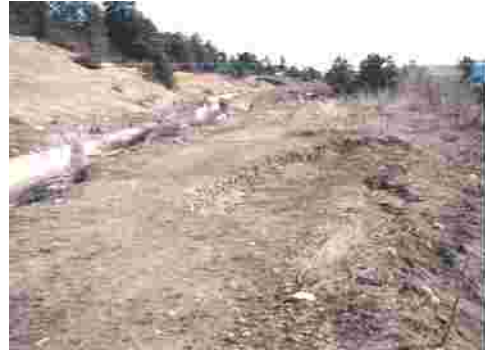
- Seepage losses in the vicinity of a previously damaged section of the canal have contributed to activation of a landslide below the canal. This landslide is actively moving and its headwall is migrating uphill towards the canal. If this seepage is not arrested quickly, a portion of the canal could slide into the lower canyon.

- Salvage an existing corrugated metal pipe and reuse it, along with additional piping, to provide a 300-foot long double pipe to replace a section of the earthen canal. This pipe section will stop seepage losses, improve drainage, and stabilize an area of active landslide.

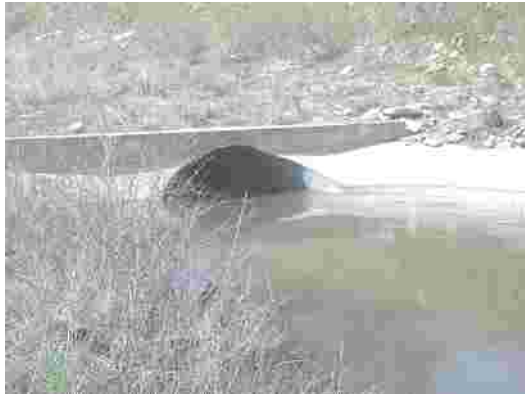
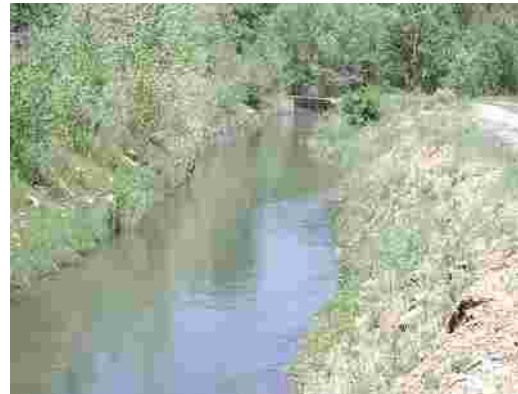
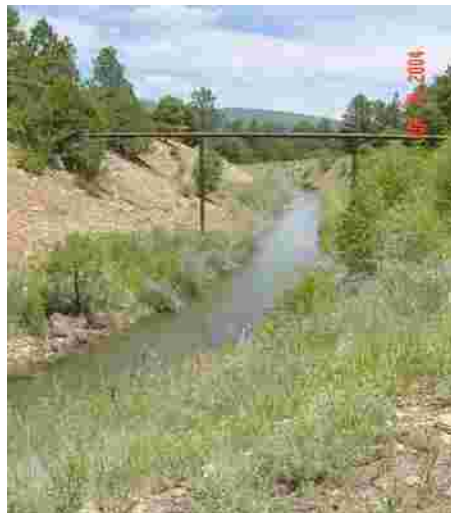
- The canal system has been found to have two flow constrictions that are limiting its hydraulic capacity to only 58% of the District's diversion entitlement. These constrictions restrict operational flexibility and the ability to optimize storage during times of uncertain supply.

- Eliminate hydraulic flow constrictions by removing a bridge and installing a 600-foot length of elliptical concrete pipe to increase flow capacity, eliminate seepage losses, improve drainage, and buttress an unstable slope.

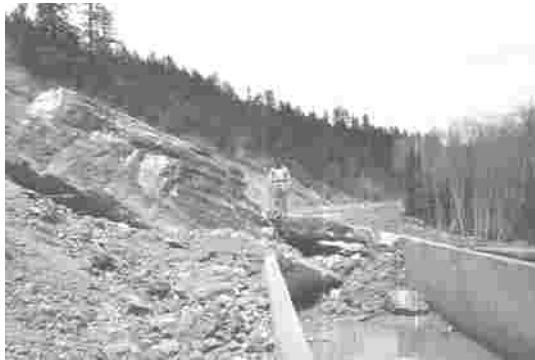
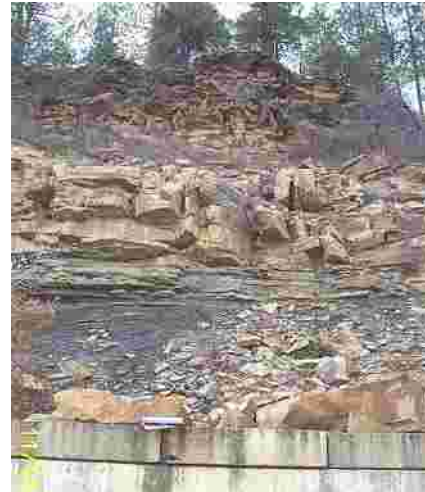
- Weak geologic formations and weathering of the steep canyon walls above the canal have created rockfall hazards. Fourteen hundred and five (1,405) linear feet of the canal system are exposed to high to moderate rockfall hazard. Rockfalls have destroyed sections of the canal in the past. Thirteen patches in the concrete walls were noted in the upper flume section alone indicating that, on average, this section of flume is damaged about every four years by impact from rockfall. If this hazard is not mitigated, pending rockfall events can be expected to take the canal out of service at any time.

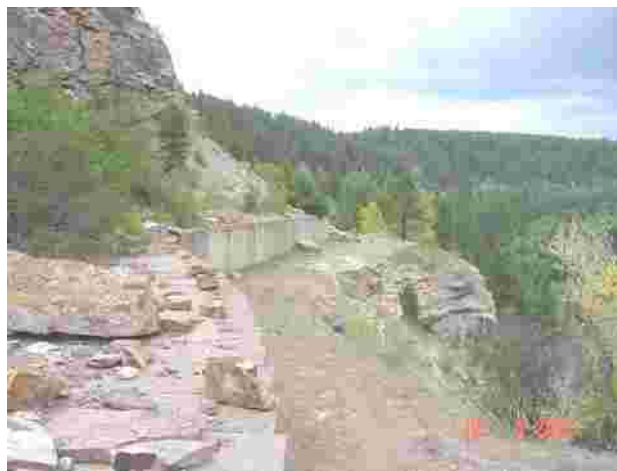
- Twenty slope failure features have been identified along the canal route. If these features are not de-watered, buttressed or otherwise stabilized, the canal will be subjected to continuous risk of damage, loss of service, and extensive maintenance problems.

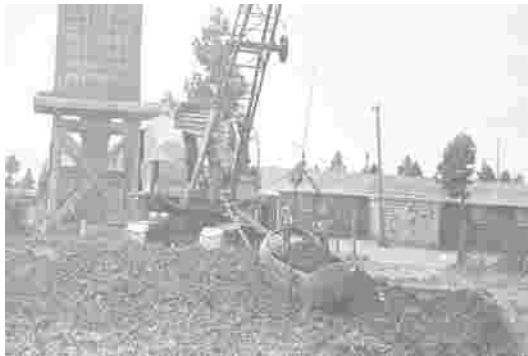
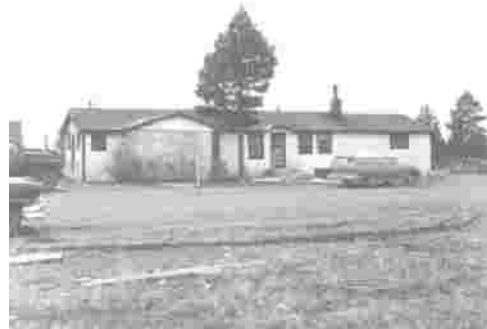
- A section of the earthen canal is subject to seepage losses that are adversely affecting the stability of a large landslide area downslope of the canal as well as the soil materials supporting the foundation of the Mancos Rural Water Company's treatment plant. Any significant movement of the hillside below the canal could result in rupture of the domestic water lines buried beneath the access road. Such rupture would terminate water flow to the Mesa Verde National Park, the Town of Mancos, and the Mancos Rural Water Company.
- Unconventional (temporary) building (operations facilities) construction method does not conform to any uniform building code.

- Restore a uniform grade within the earthen canal, dress side slopes, and apply a buffered synthetic liner to eliminate seepage loss, prevent slope instability, and reduce maintenance costs.

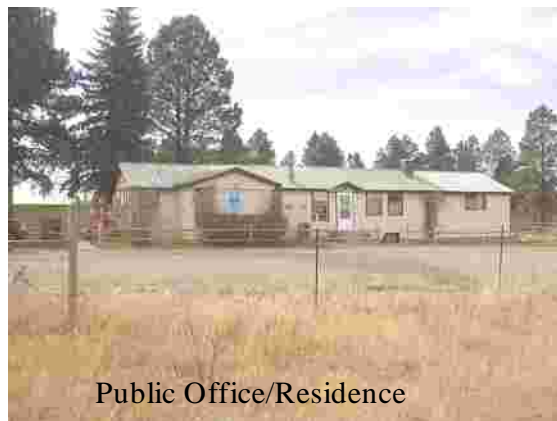
- Deterioration of concrete by displacement and stress-cracks to the foundations and floors has weakened the structural integrity of the buildings also allowing uncontrollable seasonal flooding

- The buildings do not comply to any building code and can not be made to comply.
- Existing heating system does not comply with current code and will require extensive remodel to replace.
- American Disability Act standards are not compatible with existing structural deficiencies.

- There is no method of remodel of the buildings that would be any less expensive or any more efficient than total replacement.
